OHIO HISTORIC INVENTORY

1. No. ERI-1531	4. Present Name(s) Michael Feyedelem	1. No. ERI-1531
2. County ERIE	5. Other Name(s)	2. County erie
3. Location of Negatives O.H.S.	Norman Kelley & Co.; KIL&T Co. Worker's House	4. Present Name(s) Michael Feyedelem Residence

1. No. ERI-1533		4. Present Name(s) Sticklorath Residence		1. No. ERI-1533
2. County ERIE		5. Other Name(s)		
3. Location of Negatives C.H.S.		KIL&T Co. Worker's House

1. No. ERI-1535		4. Present Name(s) Kelley Island Wine Company Ruins		1. No. ERI-1535
2. County ERIE		5. Other Name(s)		
3. Location of Negatives O.H.S.				2. County Erie

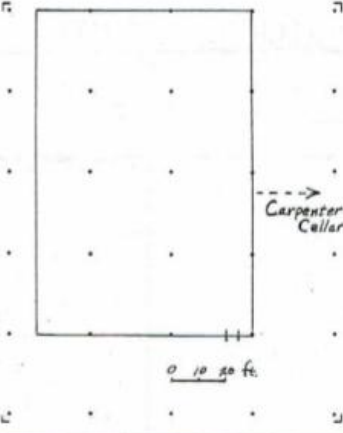
<p>54. Photo Roll No. <u>1</u> Picture No(s) <u>17</u></p>
--	--

15. Name of Established District N/A		25. Open to Public? Yes <input type="checkbox"/> No <input checked="" type="checkbox"/>		8. Other Name(s)
42. Further Description of Important Features (Continue on reverse if necessary) The winery ruins resemble the ruins of a Medieval castle with its four dominating corner towers still standing. The exterior walls are fairly intact with tower corners and the south face chimneys projecting slightly from the otherwise flush walls. The south face displays a stepped gable flanked by corbelled chimneys with concrete caps. Window and door openings are round arched, with		26. Local Contact Person or Organization Kevin Fape, KI Hist Survey

round arches above and continuous rough-faced sills below. Wider service entries are topped by segmented arches. The building is set into limestone ridges allowing a first floor service entry on the west end and an entry into the upper cellar level on the east to both be on grade. A wide opening into the lower cellar level, also at grade on the east, may have been a service entry. The cellars themselves are divided into three wine vaults per floor. The round-arched lower vaults are virtually intact while only the walls remain in the overgrown upper cellars. An arched opening and small flight of stairs connects the lower cellars with the adjacent and slightly higher cellar of Charles Carpenter's winery to the north.
